Bodie Island Light Station Double Keepers Quarters Historic Structure Report

Cape Hatteras National Seashore
Bodie Island Light Station
Double Keepers Quarters
Historic Structure Report

2009

Joseph K. Oppermann - Architect, P.A.

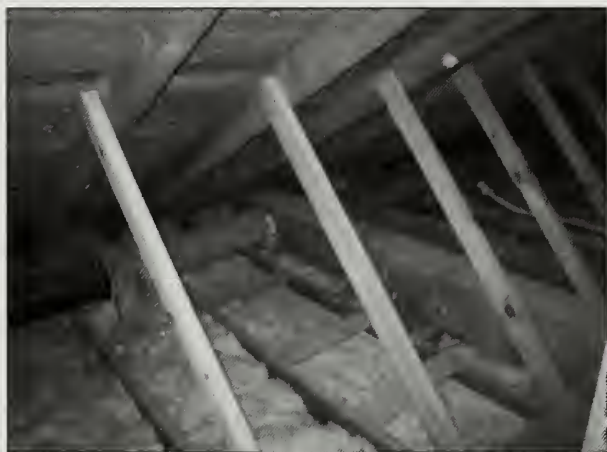
Figure 8, Diagonal bracing added in 1954 in attic to help support new oil heater.

In 1954, pine planks measuring 1½" by 3⅞" were nailed in place as a diagonal connection between rafters and joist. This was done to provide additional support for the joists as heating units were placed in the attic. The deck boards, which appear to date from different installation periods, measure 5½" in width.

Also at some point, perhaps in 1954, a modern, 1⅝" by 5½" pine board was added as a vertical brace at the connection of each rafter pair and joist. Though not on the 1954 as-built plans these vertical boards were already installed by commencement of the 1990 repairs.

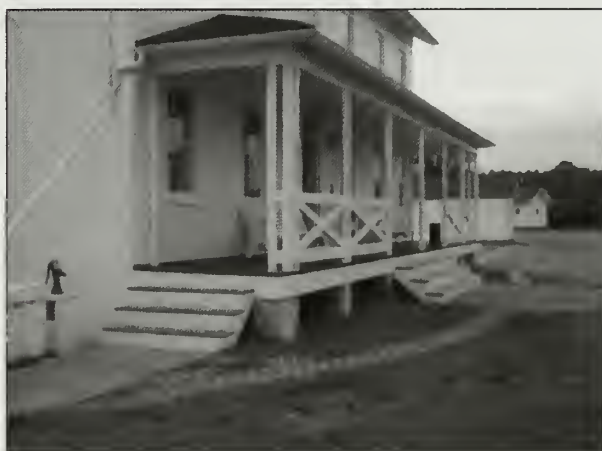
Figure 10, East Porch.

There are two rows of apparently original, low brick piers, aligned north-south, one parallel to the east exterior wall of the dwelling and the other row parallel to the west wall. Each row supports a system of wood framing for an open porch. The two end-piers of each group measure 1'-1" by 2'-1" in plan. The brick piers between the two end-piers are square in plan measuring 1'-1" by 1'-1".

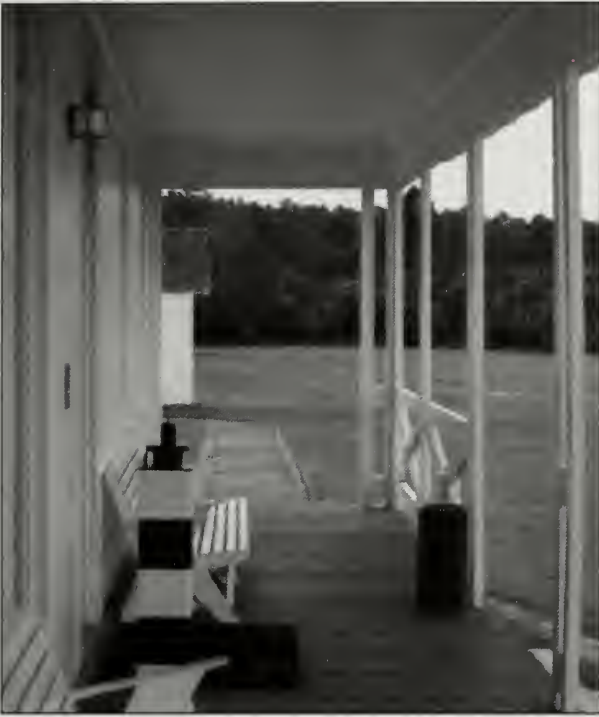
Figure 19, Looking north from East Porch.

The seven pairs of coupled posts and four sets of X-braced railings per porch are an unusual feature first documented in 1893 photographs. These configurations are probably original features given the early documentation of their existence, even though the 1872 plans call for ten solitary posts.

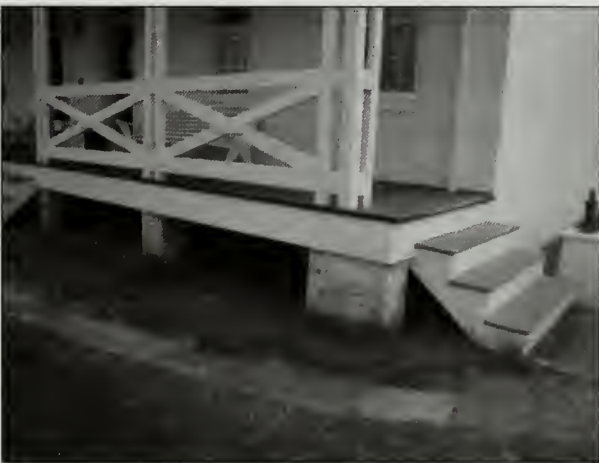
Figure 20, Side steps.

According to photographs, the paired posts and X-braced porch railings continued until 1954 when they were replaced by single posts without porch railings similar to the 1872 plans. The single posts were replaced with paired posts and X-braced rails which were in place in 1990. However, because insect damage was so severe, George Perrot, who

supervised the NPS repair effort in 1990-92, reports that all posts and rails had to be replaced. The posts measure 2" by 4". The top rail measures 1" by 5", the bottom rail 1" by 6", and the cross rail 1" by 4".

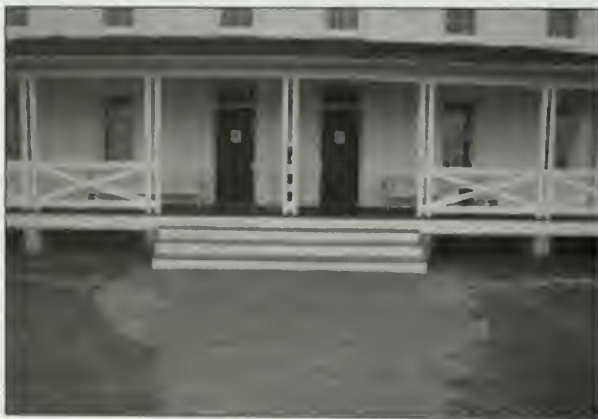
At the north and south ends of the two open porches, there are matching steps, an early if not original design feature. Each group consists of three steps and measures 5'-1" in width. The full-length treads measure 11¼" deep by 5/4" thick with a bull nose profile on the three exposed sides. The riser measures 8" in height. There are three stringers. Each measures 3" by 8", has been squared up with circular saw and cut to accommodate treads and risers. This framing is without decorative embellishment. All four of these sets of steps were extensively rebuilt in 1990-92.

Figure 24, Early brick walkway and rebuilt steps leading to East Porch entrances.

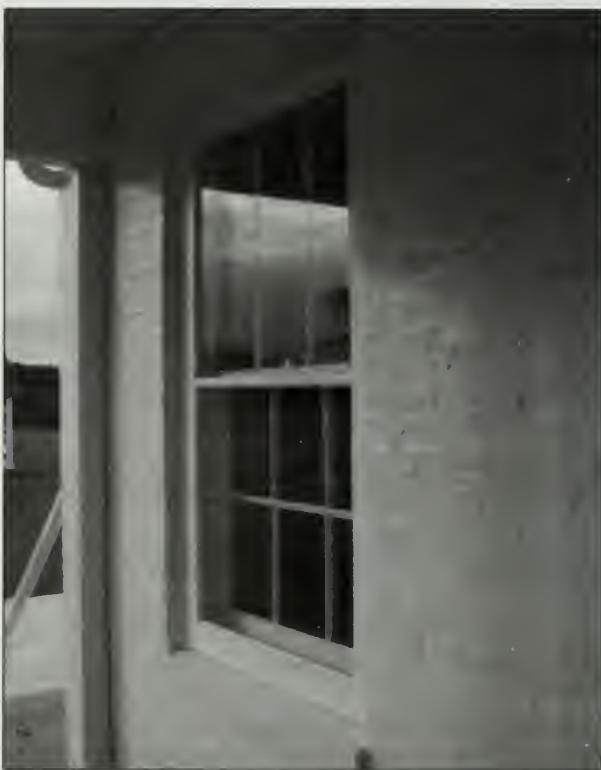
Figure 25, Typical first-floor window.

Each window opening has an exterior sash window consisting of a wood sash of full-opening dimensions with thermal glass. Two metal receivers at the top rail of each sash attach to matching hooks on the window header. The thermal windows were added during the 1990-92 repair campaign.

Also at each window are scars at the jambs from butt hinges for shutters. Shutters are shown on the building in a 1933 photograph. No evidence was observed of other shutter hardware such as plate or driven pintles, other jamb hinges, hooks, holdbacks or latches.

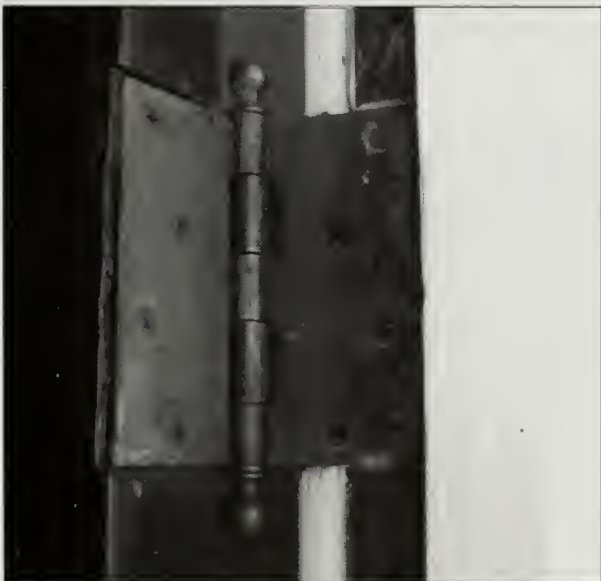
Each door has a modern mortise lock with brass pull handle and thumb latch on the exterior face. A turn is on the interior side. All four doors have a door closer. The two west doors each have three, stainless-steel, 4 inch hinges. The two doors on the east elevation each have three early brass 4-inch ball-pin hinges which are possibly the original.

Figure 27, Early brass door hinge, East Porch.

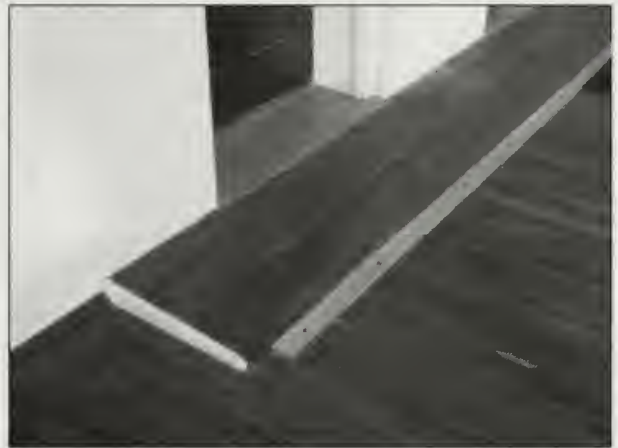
Figure 28, West Porch reducer.

Each doorway has a well-worn, perhaps original, threshold comprised of two boards side-by-side that spans the width of the masonry opening and measures 14" in total depth. Each doorway also has a modern 3 $\frac{1}{2}$ " wide oak threshold added on top of the early threshold.

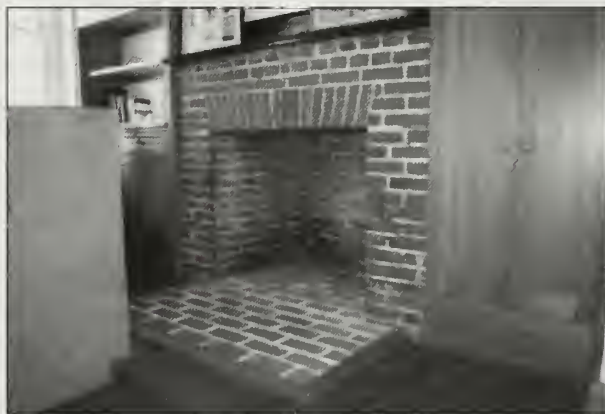
Figure 42, Fireplace of Room 101.

On the north wall is the exposed-brick fireplace for the original Kitchen. The early if not original firebox is intact. The opening measures 3'-3" across at the front face and 1'-1" deep, the beveled cheek walls forming a 2'-4" wide back wall. Many of the brick along the back of the firebox have heat fractures and spalled exposed surfaces. A metal strap supports the flat arch of the hearth. In 1990-92 a

new brick hearth measuring 4'-3" wide and 2'-1" deep was laid. Also during those repairs, a Dutchman repair was made to the front of the mantel shelf. In 1954, the front of the shelf was hacked off to enclose the fireplace with a stud wall.

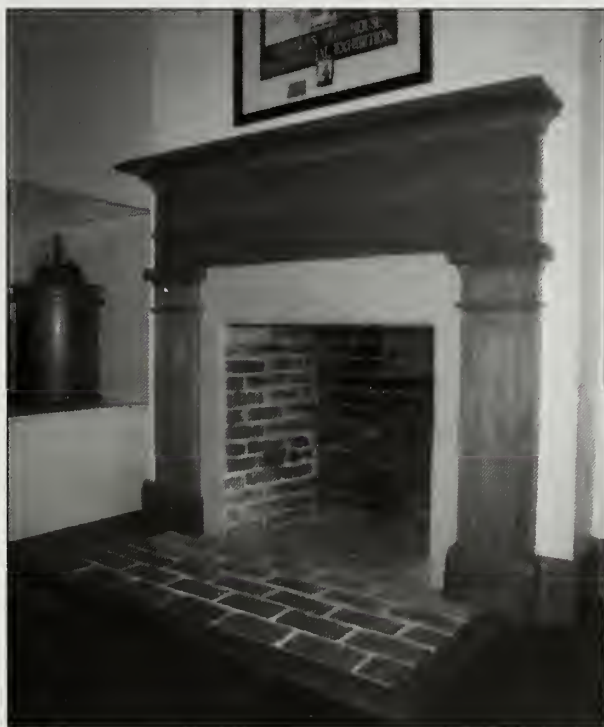
Figure 62, Fireplace and 1992 replacement mantel of Room 110.

beveled cheek walls forming a 2'-1" wide back wall. Some of the brick along the back of the firebox have heat fractures and spalled exposed surfaces. In 1990-92 it was reconstructed using the fireplace mantelpieces at the St. Augustine, FL, Lighthouse Keepers' Quarters as a model in combination with features and details found in this building and the nearby Oil House. Also in 1990-92, a new brick hearth measuring 4'-1" wide and 2'-1" deep was laid.

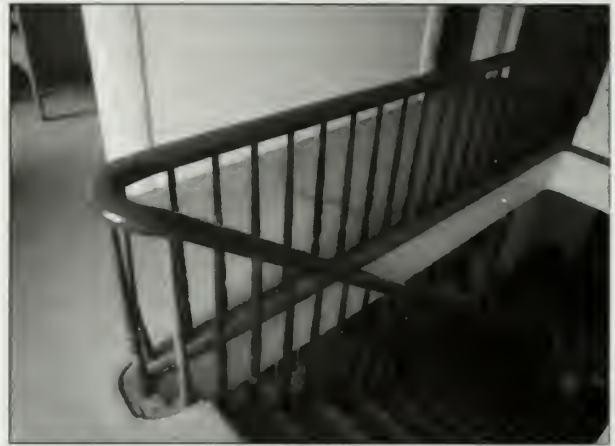
The original 1872 staircase is partially intact at this level. A large section of the original handrail and

balusters were apparently lost when part of the hall was made a storage area post-1954 and pre-1989. The storage room was removed and the missing staircase elements reproduced for reconstruction of the hall during the 1990-92 campaign.

Figure 67, Staircase at second level.

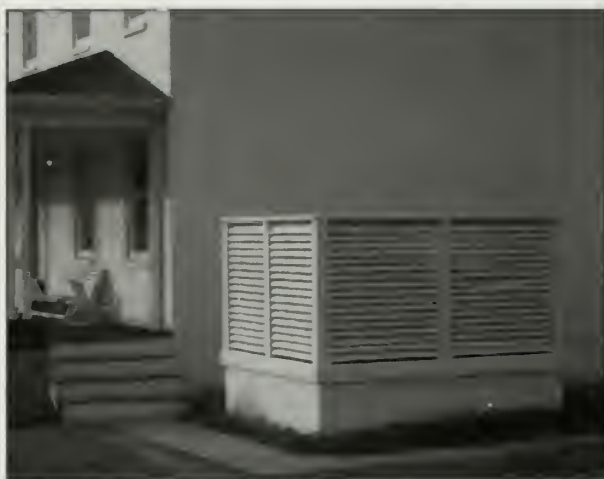
Figure 77, Enclosure for heat pumps.

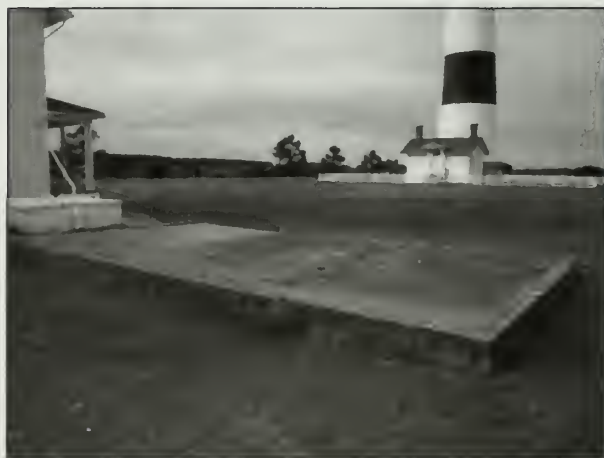
Just 25 feet south of the south-side cistern is the north edge of a poured concrete slab of a wood shed constructed in 1930. This slab measures 28'-3" north-south and 14'-9½" east-west with a 1'-0" wide step along the east edge. Height above grade is about 1'-0". Imprints in the top of the slab indicate interior subdivision of rooms.

Figure 78, Southwest oblique of the Wood Shed's concrete Slab Foundation.

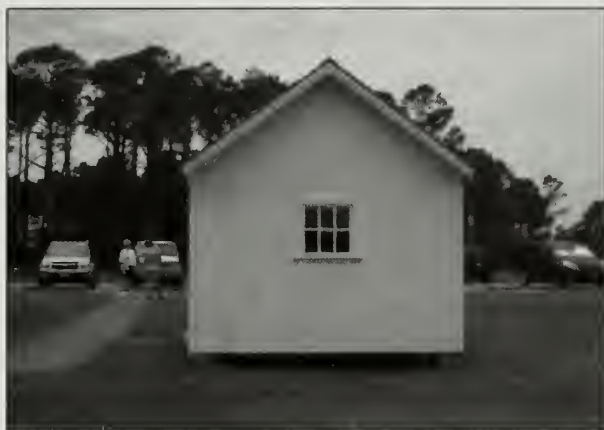
Figure 79, East elevation, 1920 Storage Shed.

The building is wood framed, covered on the exterior by what appears to be the original board-and-batten siding. The plank boards measure 1'-0" by ⅞". The square-edge battens measure 1" by 2".

In the 1990-92 repair campaign, the building was raised to a height of about 2'-0" above grade and placed on eight new brick piers each measuring 1'-0" by 1'-0".

- Replace the wood shingle roofing of the Quarters and the Storage Shed;
- Repaint the painted exterior wood elements;
- Re-oil exterior wood porch flooring;
- Re-varnish interior first-floor wood flooring;

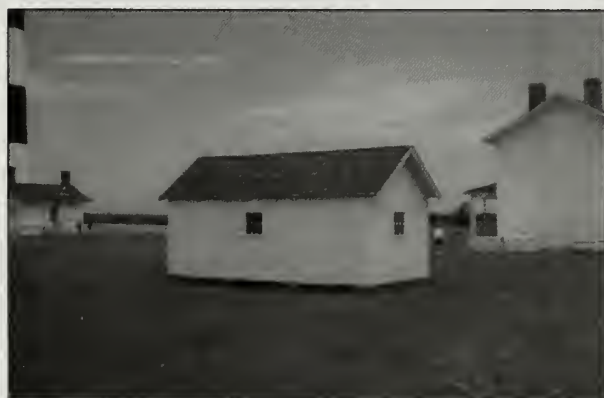
A single, four-light, fixed window sash is centered on each of the east, north and west walls. The windows are identical and were installed as replacements in 1990-92. There is no evidence of window hardware.

Figure 80, Northwest oblique of the 1920 Storage Shed.

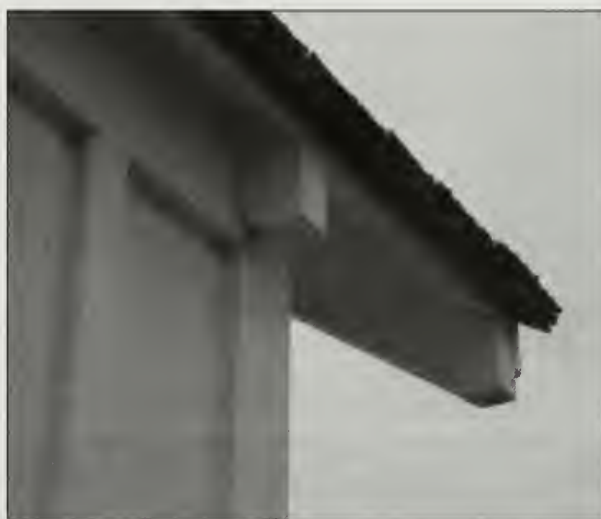
Figure 81, Exposed rafters, the 1920 Storage Shed.

The gable roof has a cedar-shingle roofing material matching that of the Quarters. This roof was installed in 1990-92.

The gable roof is framed with original rafters measuring 1⅝" by 3¾" set at 26 inches on center. Every other pair of rafters has an original ¾" by 5½" collar beam. Deck boards measure ¾" by 5½".

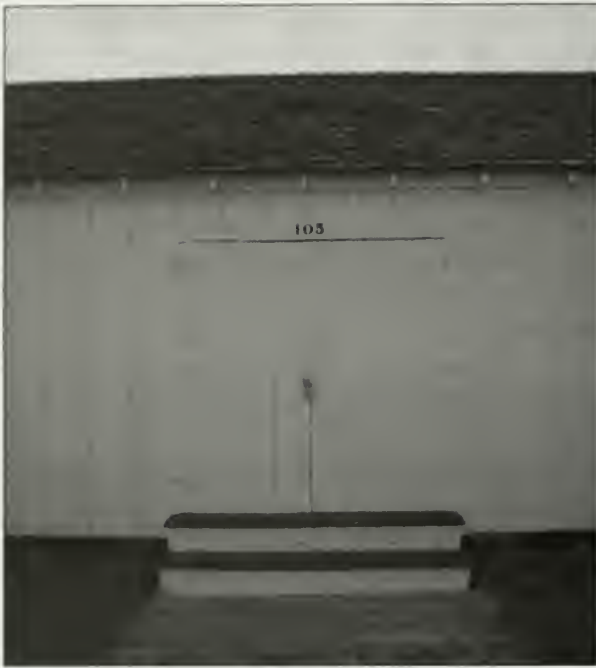
Entry inside the building is by way of three wooden steps at the center of the south elevation. The two-board treads measure 10½". The two-board risers measure 8". The steps are 6'-4½" wide. There is no landing at the top of the steps.

Figure 82, South elevation doorway, the 1920 Storage Shed.

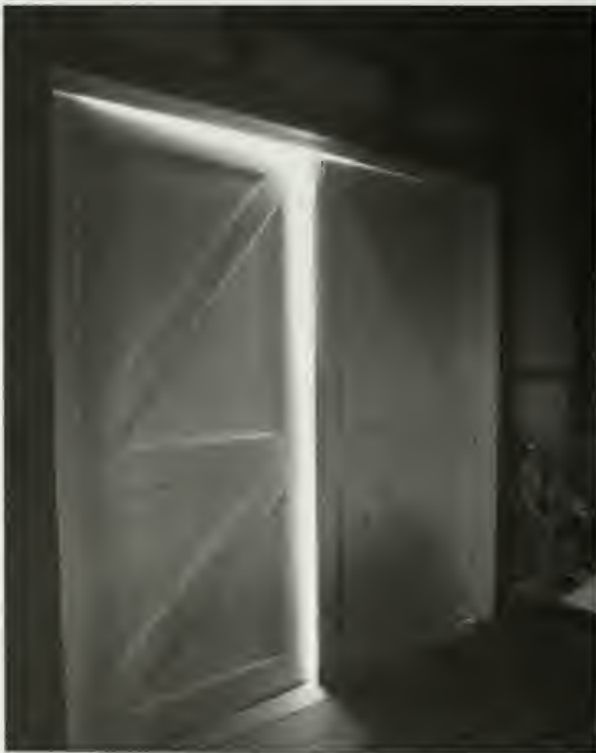
Centered on the south wall is a doorway with double doors. The doors measure 6'-0" tall by 1¾" thick by 5'-11½" wide and are constructed of vertical boards measuring ⅞" thick by 5½" wide including a ¼" edge bead. Two cross-bracing, chamfered boards measure ⅞" thick by 4" wide. Each door has three strap hinges of 11 inches in length when fully open. There are ghost marks indicating the same style and size of hinges having been used previously.

Figure 83, Double doors.

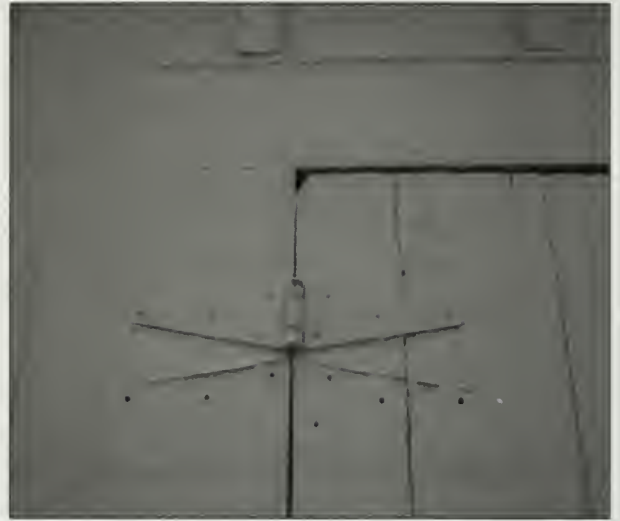
Figure 84, Doorway and hardware, the 1920 Storage Shed.

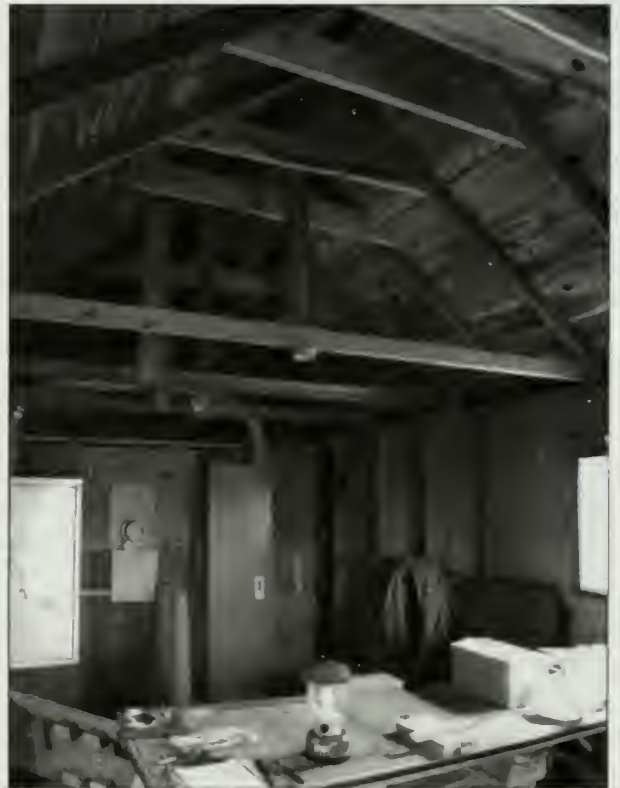
Without a ceiling above, and there is no indication that there ever was one, the roof framing and underside of the roof deck are clearly visible. The original tongue-and-groove flooring remains. It consists of boards of random widths of $4\frac{1}{2}$ ", $5\frac{1}{4}$ ", and $5\frac{1}{2}$ ".

Figure 85, Northwest oblique of the interior, the 1920 Storage Shed.

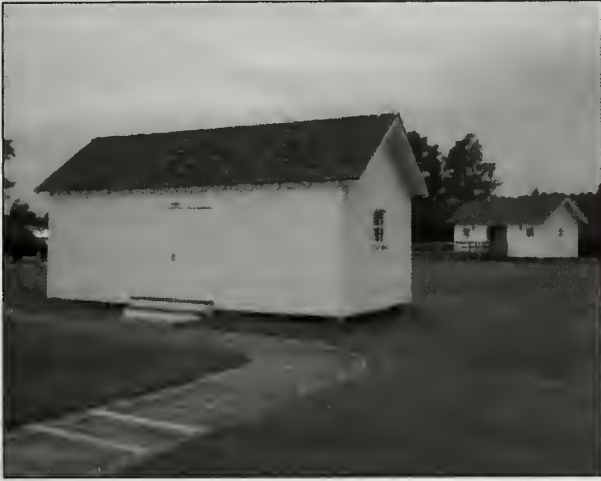
Beyond the Storage Shed another 100 feet to the north is a 1992 frame building on exposed brick piers. The exterior wall siding is board-and-batten. The roofing material is the same wood shingle found on the Storage Shed and the Quarters.

Figure 86, The 1920 Storage Shed in foreground and the 1992 Public Restroom Building behind.
